Manhole Inspection Summary

Manhole # S29G__020MH

Insp Date: **1/26/09 11:07 AM**

Location Address: **4 N Fremont Ave**

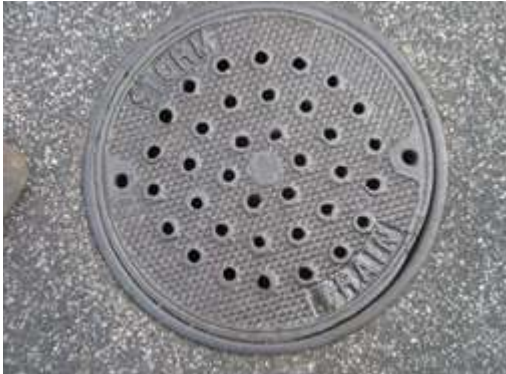
Miscellaneous

wrong lid

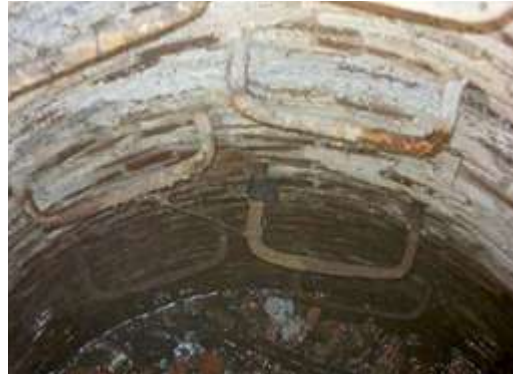
Defect 1

Count: **7** Missing: **0** ☒ **Corroded**

☒ **Evidence Of Surcharge**

Depth: **2**

corroded rungs, evidence of surcharge 2 ft

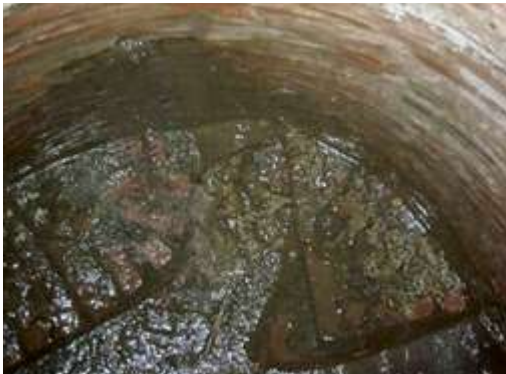
Defect 2

Condition: ☐ Sound ☐ Cracked ☐ Root Intrusion ☐ Deteriorated ☐ Leaks ☒ **Debris**

bench & channel debris

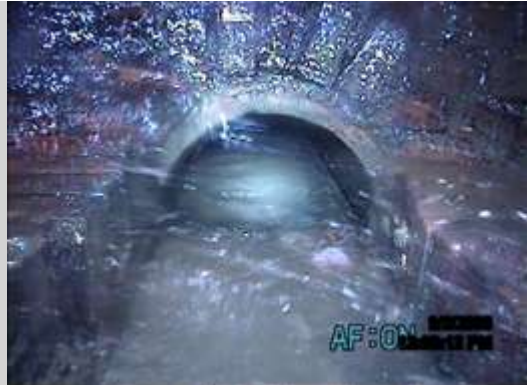
12 O'Clock Outflow

12 in. Circular Gravity Sewer
Pipe Out @ 12 O'Clock

Pipe Height: **10.8** (in.) Rod and Bar (Angled)
Pipe Material: **Clay** ☐ Pipe Lined
Invert Depth: **12.85** (ft.) Flow Characteristics: **Fast**
Deposits: ☒ None ☐ Mud ☐ ~~Sludge~~ ☐ Debris ☐ Grease
Silt Depth: **0** (in.) Deposits Extent:
Infiltration: **None** Pipe Seal Cond: **Sound**

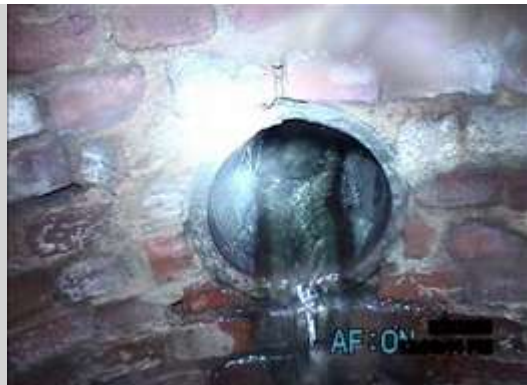
4 O'Clock Inflow

8 in. Circular Gravity Sewer
Pipe In @ 4 O'Clock

Pipe Height: **8.4** (in.) Rod and Bar (Angled)
Pipe Material: **Clay** ☐ Pipe Lined
Invert Depth: **8.00** (ft.) Flow Characteristics: **Fast**
Deposits: ☐ None ☐ Mud ☒ ~~Sludge~~ ☐ Debris ☐ Grease
Silt Depth: **0** (in.) Deposits Extent: **Medium**
Infiltration: **Evidence** Pipe Seal Cond: **Sound**

Drop: **Outside** Rod and Bar
Angled: **Yes** Reading: **11.20** (ft.)
Inv Depth: **12.20** (ft.)
Drop Condition: **Partly Clogged**

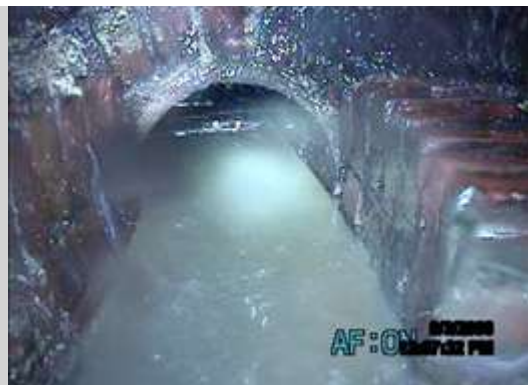
7 O'Clock Inflow

10 in. Circular Gravity Sewer
Pipe In @ 7 O'Clock

Deposits: ☐ None ☐ Mud ☒ **Sludge** ☐ Debris ☐ Grease

Silt Depth: **0** (in.) Deposits Extent: **Medium**
